Manhole Inspection Summary

Manhole # S39AA_059MH

Insp Date: **11/28/07 9:56 AM**

Location Address: **e. monument**

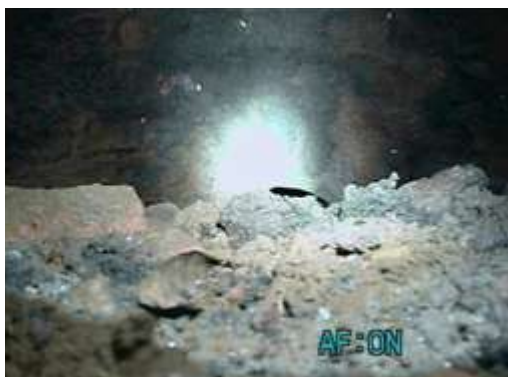
Defect 5

Condition: ☐ Sound ☐ Cracked ☐ Root Intrusion ☐ Deteriorated ☐ Leaks ☒ **Debris**

channel debris

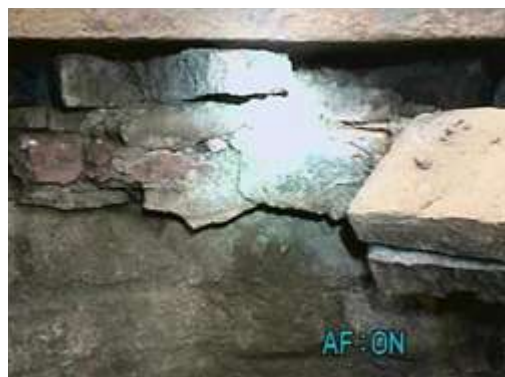
Defect 3

Condition: ☐ Sound ☒ **Cracked** ☐ Root Intrusion ☒ **Loose Brick** ☒ **Deteriorated**

cracked, loose bricks and deteriorating chimney

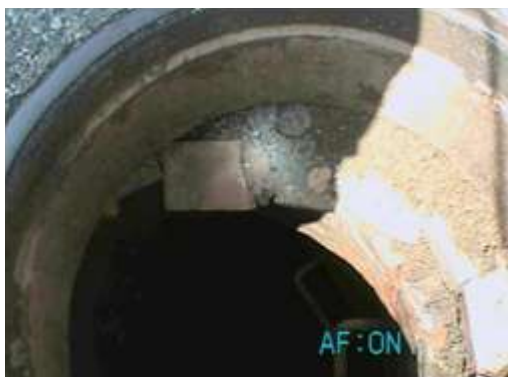
Defect 2

Frame Offset: **5** (in.) Condition: ☒ Sound ☐ Cracked ☐ Leaks

offset

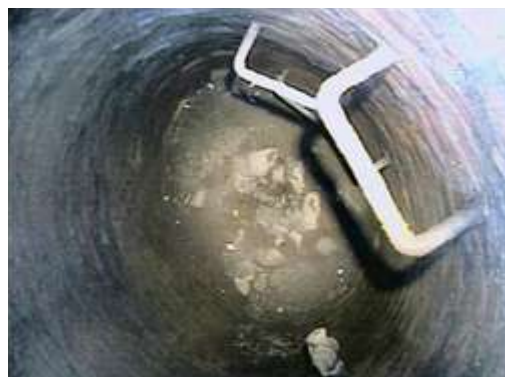
Defect 1

Infiltration: ☐ None ☐ Joint ☐ Cracks ☐ Mortar ☐ Roots ☒ **Wall**

Steps Count: **4** Missing: **0** ☒ **Corroded**

Barrel wall Infiltration, corroded steps

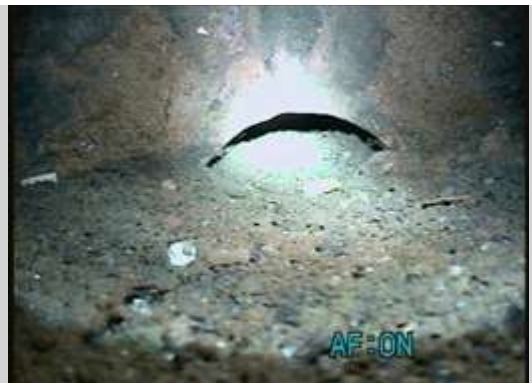
12 O'Clock Outflow

Deposits: ☐ None ☐ Mud ☐ Sludge ☒ **Debris** ☐ Grease

Silt Depth: **6** (in.) Deposits Extent: **Heavy**
